**TRI COUNTY FISH TEAM
FISH PASSAGE IMPROVEMENTS**

**EXISTING CROSSING CONDITIONS
4-BARREL BOX CULVERT
SAN ANTONIO CREEK AT OJAI VALLEY TRAIL
VENTURA COUNTY**

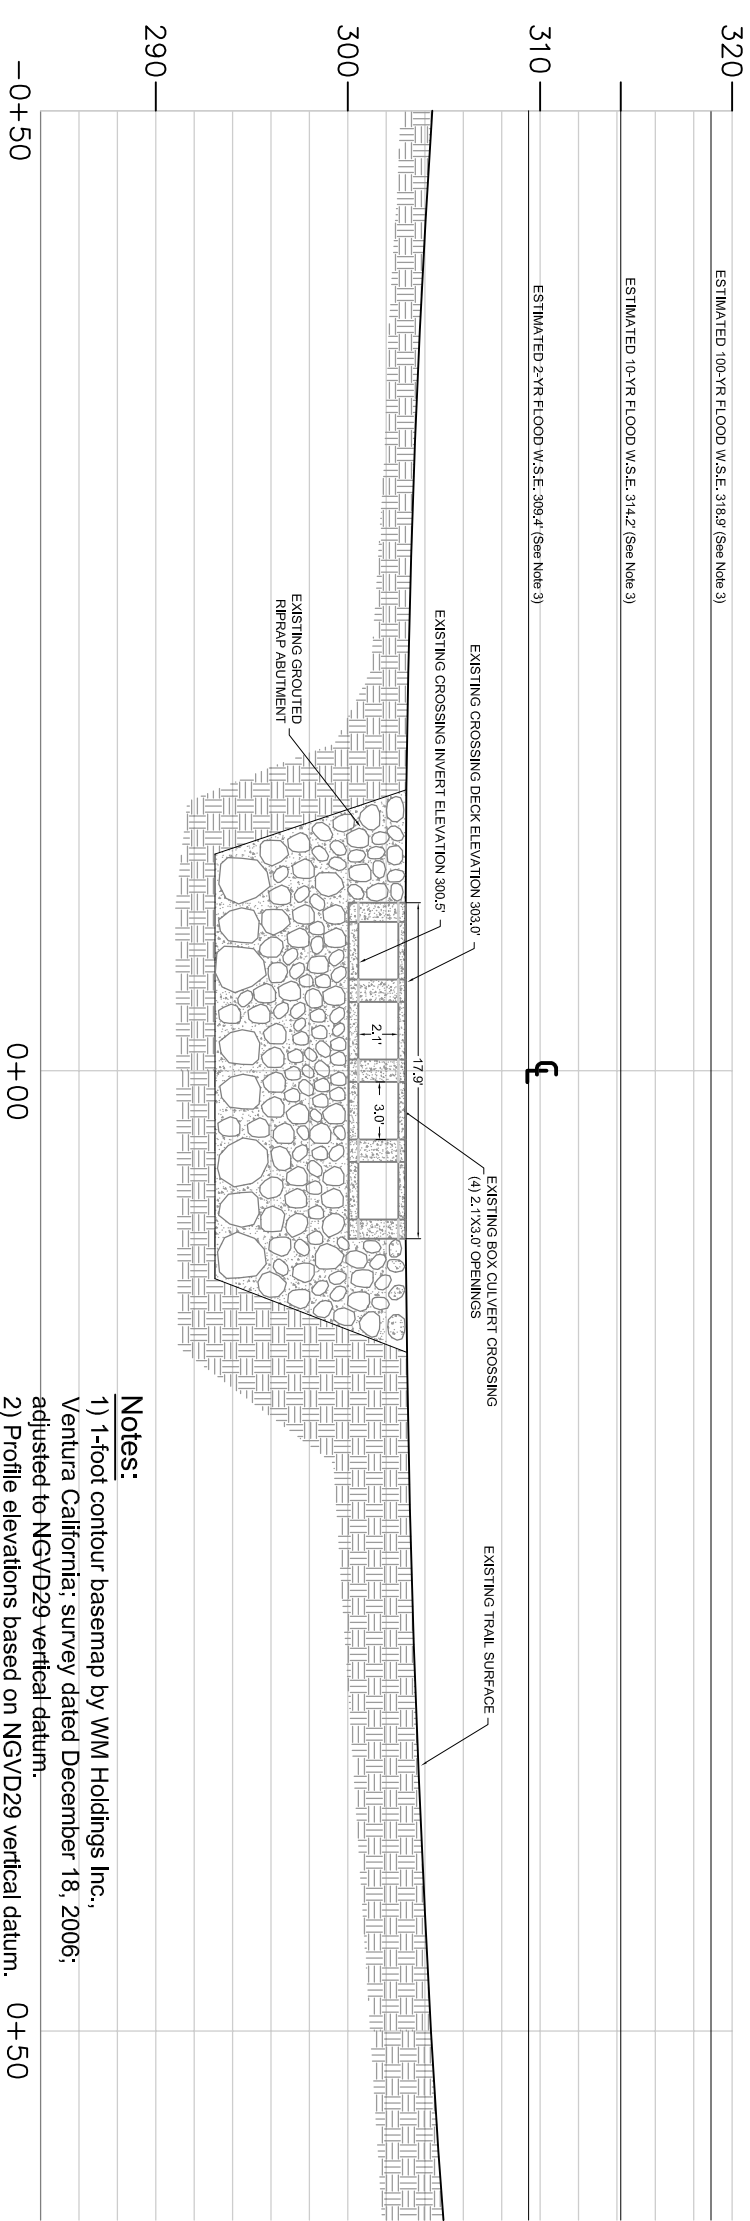
EXISTING CROSSING PROFILE
SCALE (HORIZ./VERT.): 1" = 10'

- Notes:**
- 1) 1-foot contour basemap by WM Holdings Inc., Ventura California; survey dated December 18, 2006; adjusted to NGVD29 vertical datum.
 - 2) Profile elevations based on NGVD29 vertical datum. 0+50
 - 3) HEC-RAS by Hawks & Assoc., January 2007; output for Sta. 108.23; Report refers to NAVD88, HEC-RAS output conforms to NGVD29 elevations.
